The Fire Resistance Performance of a Specimen of a Loadbearing Timber Floor Assembly Protected by a Plasterboard Ceiling Designed to Provide 60 minutes Fire Resistance, Incorporating Twenty Downlight Light Fittings, Tested in Accordance with BS 476: Part 21: 1987, Clause 7

371969B

371967B

370975B

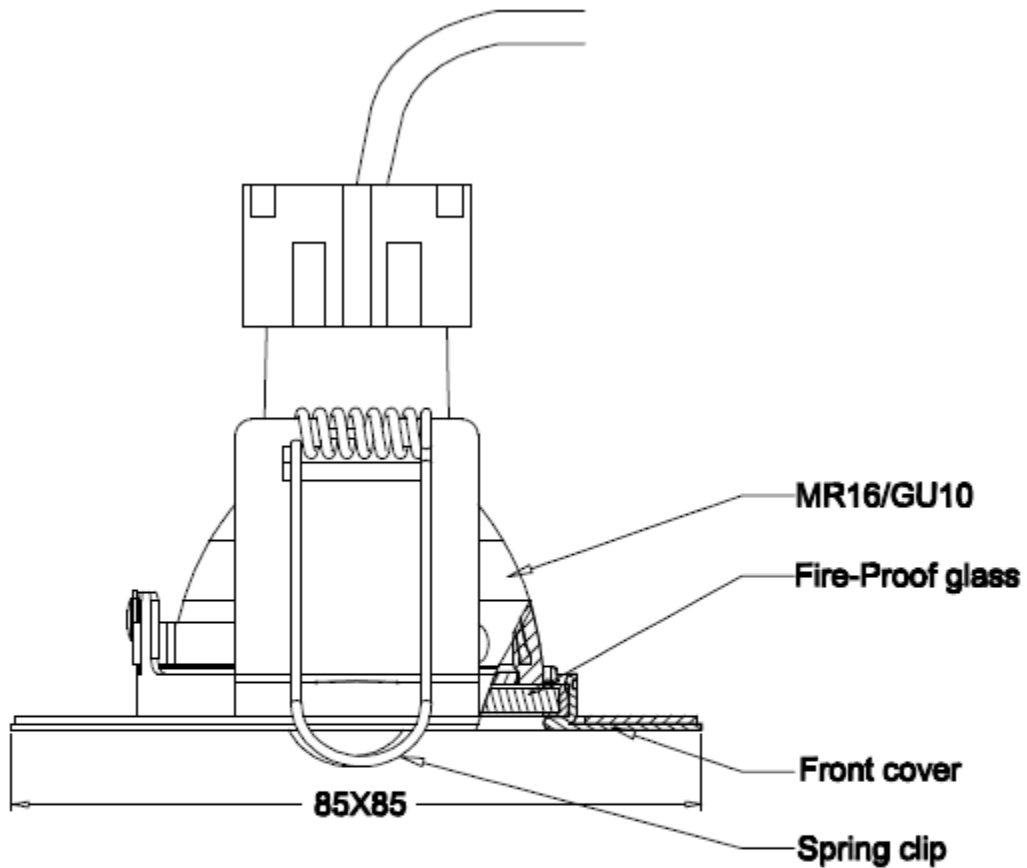
Figure 8 – Details of Downlighter Specimen F

**Fixed model  
ILDLFR70DXXX  
Slim fire square bezel  
Cut out:Ø70mm**

<b><u>Item</u></b>	<b><u>Description</u></b>
<b>3. Specimen F, G, H, I</b>	
Manufacturer	: Integral LED
Type	: Square, fixed, LED recessed downlight
Reference	: See Figures 8 to 11.
Materials	
i. front cover	: Steel
ii. spring	: Stainless steel
iii. diffuser	: Pyrex glass
Overall dimensions and construction	: Please see Figures 8 to 11
Cut out size	: Various see relevant figures
Driver	: None
Lamp	: GU10/MR16
<b>4. Specimen J</b>	: Specimen reported separately
<b>5. Specimen K, L</b>	: Specimens reported separately
<b>6. Specimen M, N</b>	: Specimens reported separately
<b>7. Specimens O</b>	: Specimen reported separately
<b>8. Specimens P</b>	: Specimen reported separately
<b>9. Specimen Q</b>	: Specimen reported separately
<b>10. Specimens R, S</b>	: Specimens reported separately
<b>11. Specimen T</b>	: Specimen reported separately

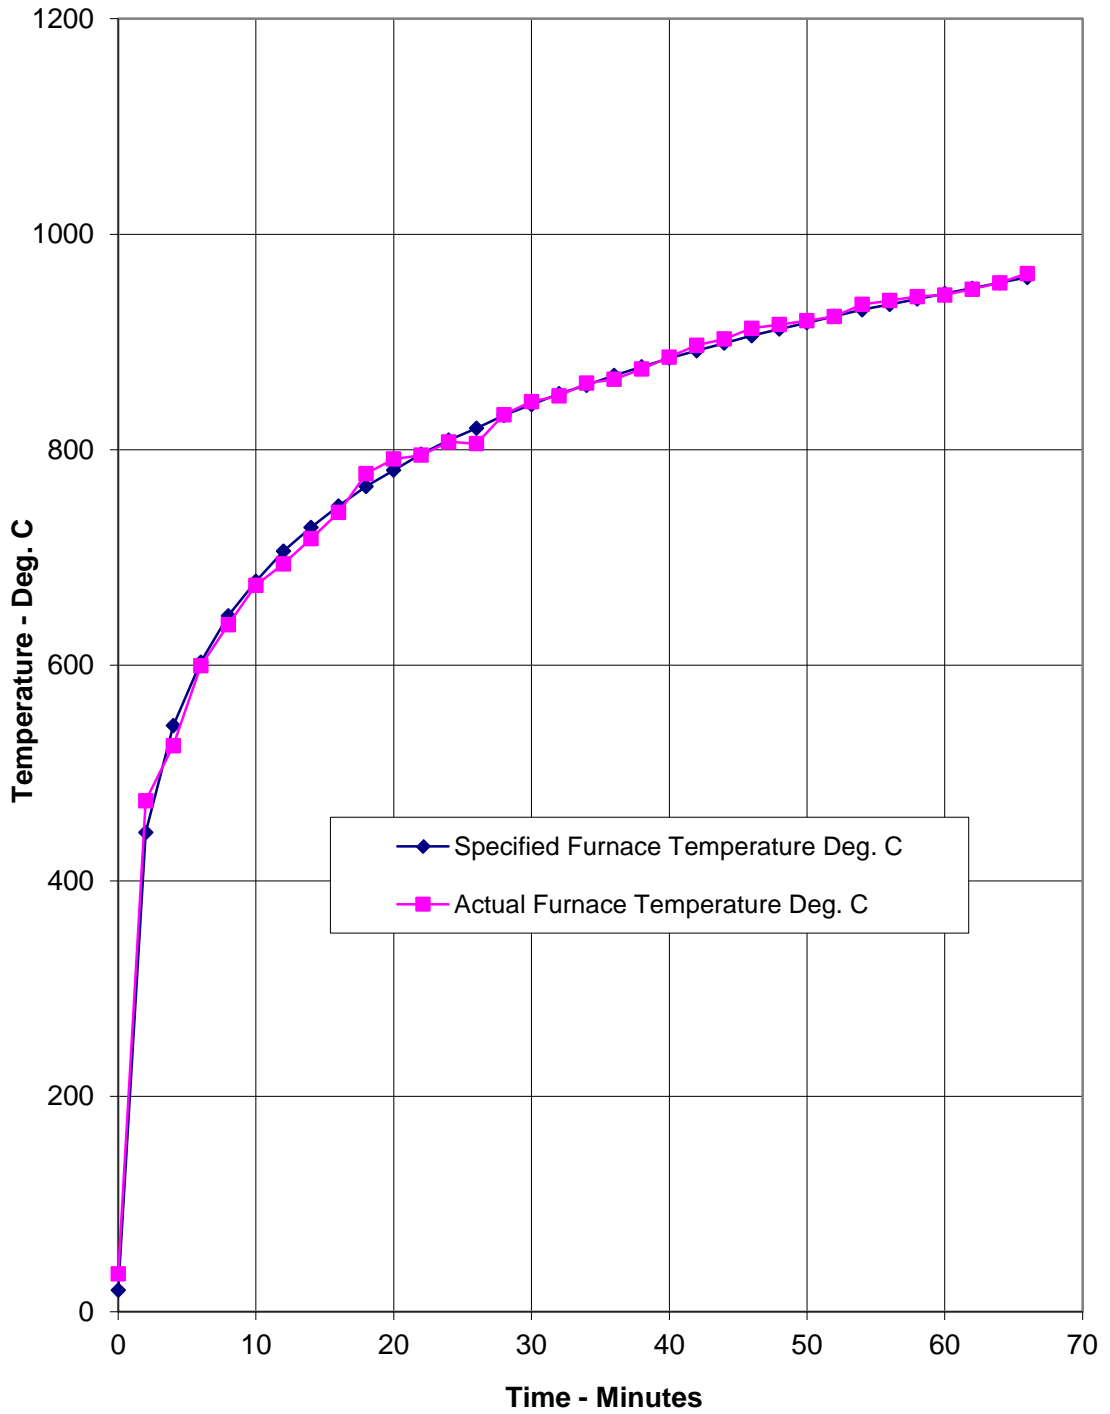
Graph showing specified and actual furnace temperatures

Time Mins	Specified Furnace Temperature Deg. C	Actual Furnace Temperature Deg. C
0	20	35
2	445	474
4	544	526
6	603	600
8	646	638
10	678	674
12	706	694
14	728	718
16	748	742
18	766	778
20	781	792
22	796	795
24	809	807
26	820	806
28	832	833
30	842	845
32	852	850
34	860	862
36	869	865
38	877	875
40	885	886
42	892	897
44	899	903
46	906	913
48	912	916
50	918	920
52	924	924
54	930	935
56	935	939
58	940	942
60	945	944
62	950	949
64	955	955
66	960	964
