The Fire Resistance Performance of a Specimen of a Loadbearing Timber Floor Assembly Protected by a Plasterboard Ceiling Designed to Provide 90 minutes Fire Resistance, Incorporating Sixteen Downlight Light Fittings, Tested in Accordance with BS 476: Part 21: 1987, Clause 7

388542A Issue 2

26th January 2018

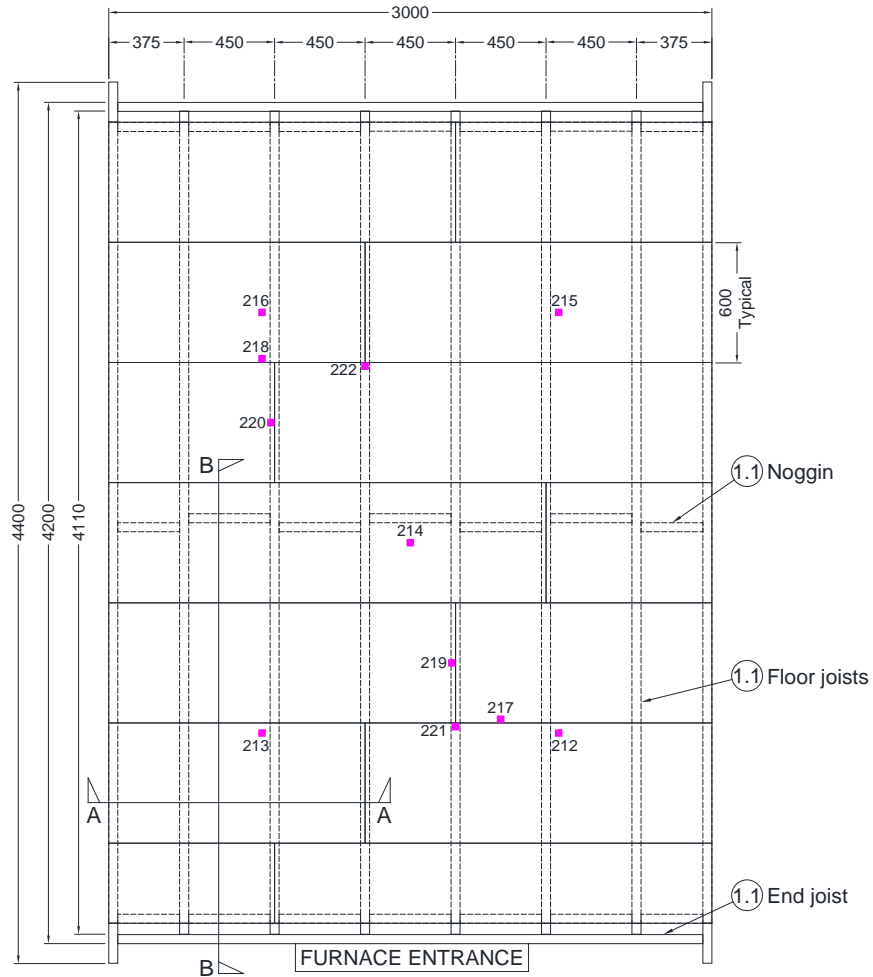
Figure 1- General Elevation of Test Construction

Key
 ■ Surface thermocouple

(Refer to Figures 1 to 4)
(All values are nominal unless stated otherwise)
(All other details are as stated by the sponsor)

<u>Item</u>	<u>Description</u>
1. Timber Floor	
1.1 Floor Joists	
Material	: British Home-grown, rough sawn softwood, kiln dried
Grade	: C16, to BS EN 519
Density	: 511 kg/m ³
Size	: 45 mm x 197 mm
Joist centres	: 450 mm

1.2 Noggins	
Material	: British Home-grown, rough sawn softwood, kiln dried
Grade	: C24, to BS EN 519
Density	: 511 kg/m ³
Size	: 65 mm x 45 mm
Joist centres	: 1200 mm

1.2 Floor Boards	
Material	: Flooring grade tongue and groove chipboards
Reference	: FSC E1 P5
Thickness	: 22 mm
Size	: 450 mm wide
Fixing	: Fixed in a single layer with 6 mm diameter x 60 mm long countersunk steel screws to floor joists at 300 mm centres

1.3 Ceiling Boards	
Manufacturer	: British Gypsum
Type / reference	: Gyproc Fireline Wallboard
Density	: 803 kg/m ³
Thickness	: 30 mm, 2 layers of 15 mm thick
Fixing

i. method	: The boards were screw fixed to the soffit of the joists with all joints in the second layer staggered with respect to those of the first layer
ii. fixings	: Drywall self drill and tapping screws 38 mm and 50 mm long for the 1 st and 2 nd board layers respectively
iii. frequency	: 150 mm centres along joints and 150 mm to the perimeter of the ceiling

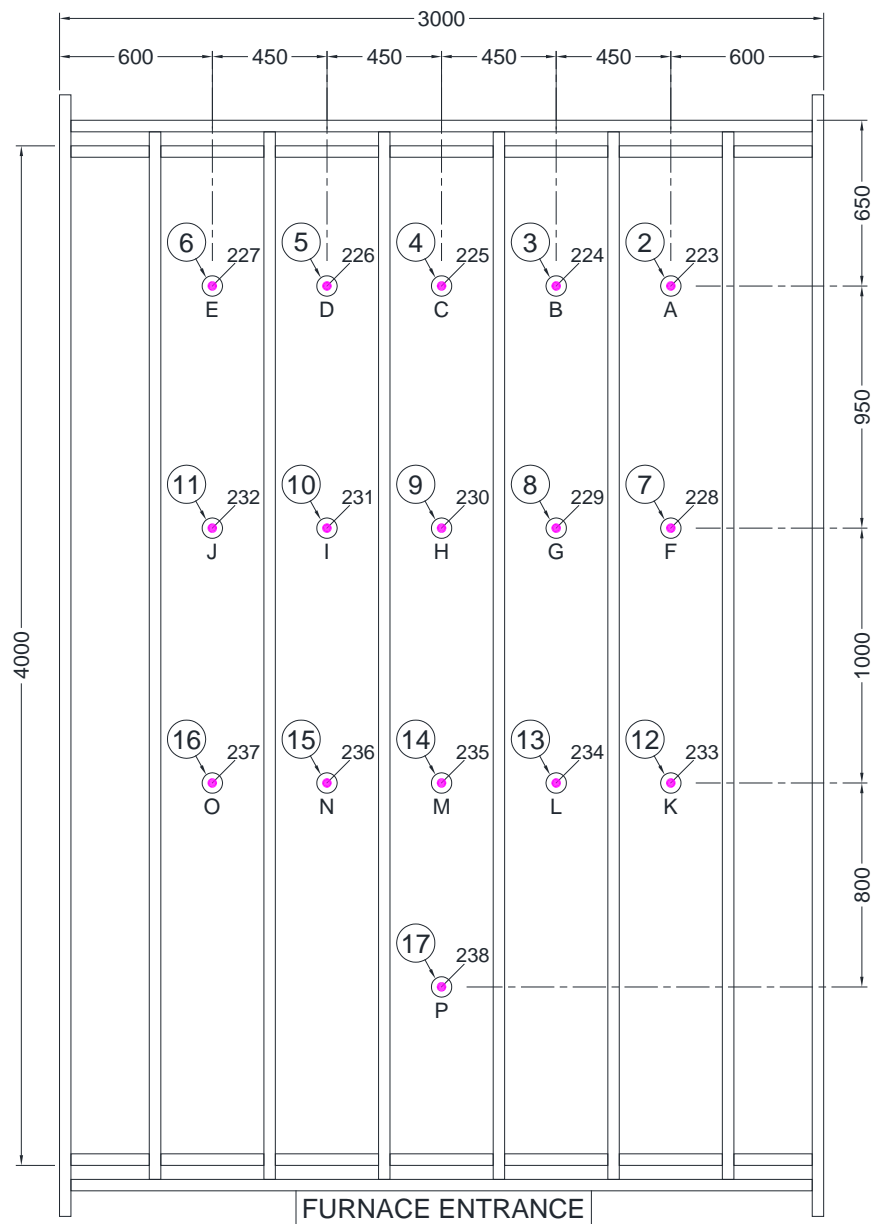
Figure 2 – Details of Downlighter Positions

● Mineral insulated thermocouples at mid-cavity height

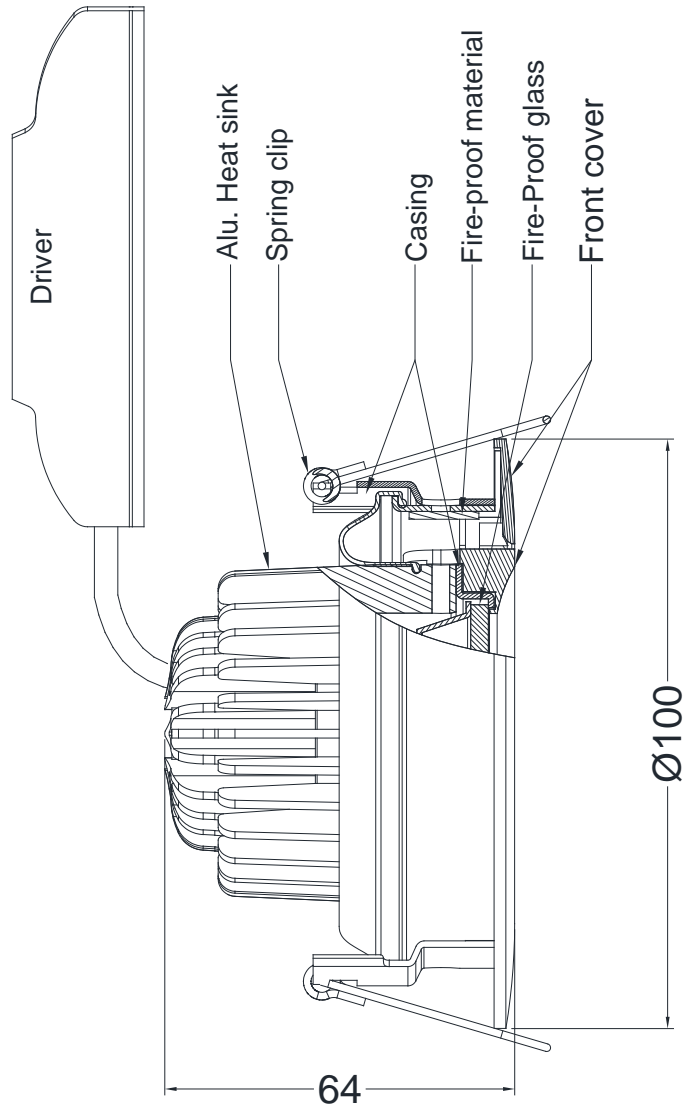
Figure 3 – Details of Downlighters Specimen K

Tilttable
With reflector ILDLFR92CXXX
Cut out: $\varnothing 92$

10. Specimen I	: Item reported separately
11. Specimen J	: Item reported separately
12. Specimen K	
Manufacturer	: Integral LED
Type	: Round, tiltable, LED recessed downlight
Reference	: ILDLFR92CXXX
Materials

i. casing	: Mild steel
ii. front cover	: Die cast aluminium
iii. heat sink	: Die cast aluminium
iv. spring clip	: Stainless steel
v. gasket	: 4.3 mm wide x 1.7 mm thick flexible plastics ring
Overall dimensions and construction	: See Figure 13 for details
Cut out size	: 92 mm diameter
Driver	: None
Lamp	: COB

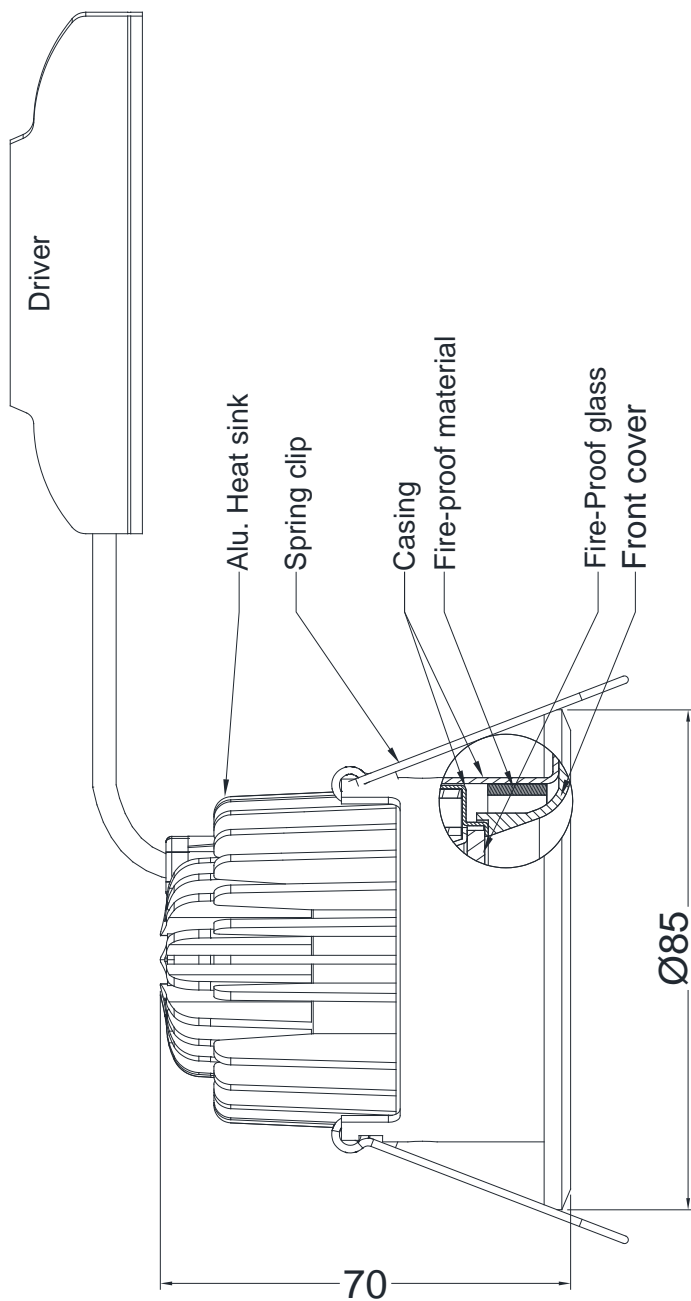
Figure 4 – Details of Downlighters Specimen M

Fixed
With reflector ILDLFR70AXXX
Cut out: Ø70

14. Specimen M	
Manufacturer	: Integral LED
Type	: Round, fixed, LED recessed downlight
Reference	: ILDLFR70AXXX
Materials	
i. casing	: Mild steel
ii. front cover	: Die cast aluminium
iii. heat sink	: Die cast aluminium
iv. spring clip	: Stainless steel

v. gasket	: 4.3 mm wide x 1.7 mm thick flexible plastics ring
Overall dimensions and construction	: See Figure 15 for details
Cut out size	: 70 mm diameter
Driver	: None
Lamp	: COB

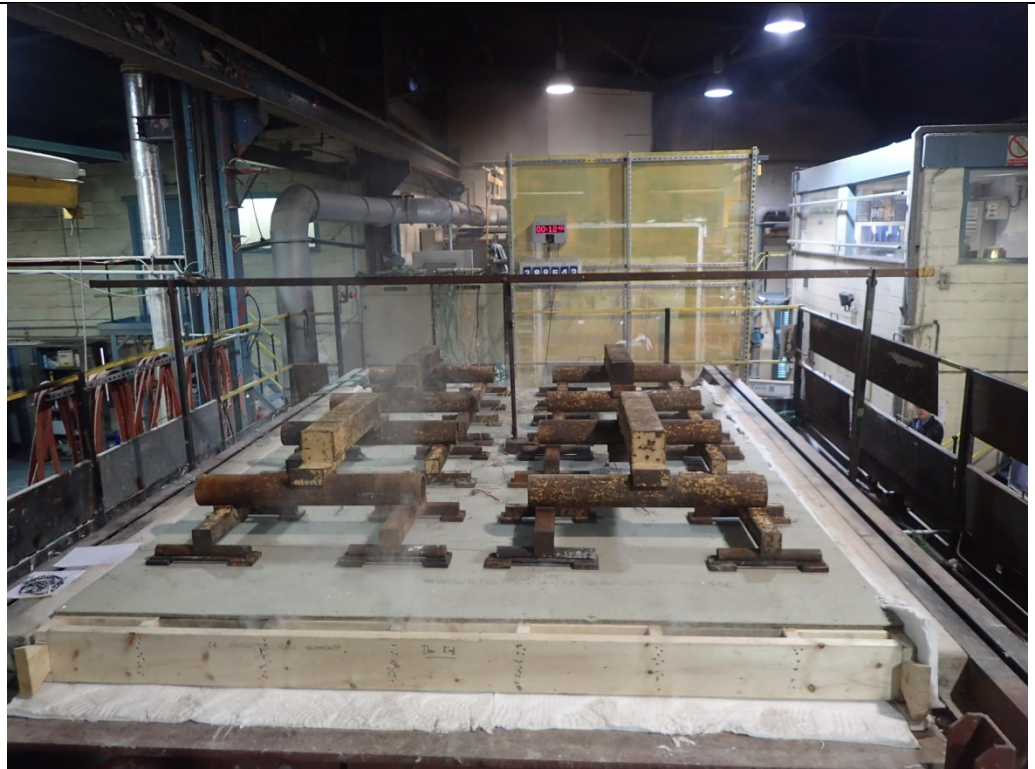
The unexposed face for the assembly after a test duration of 12 minutes

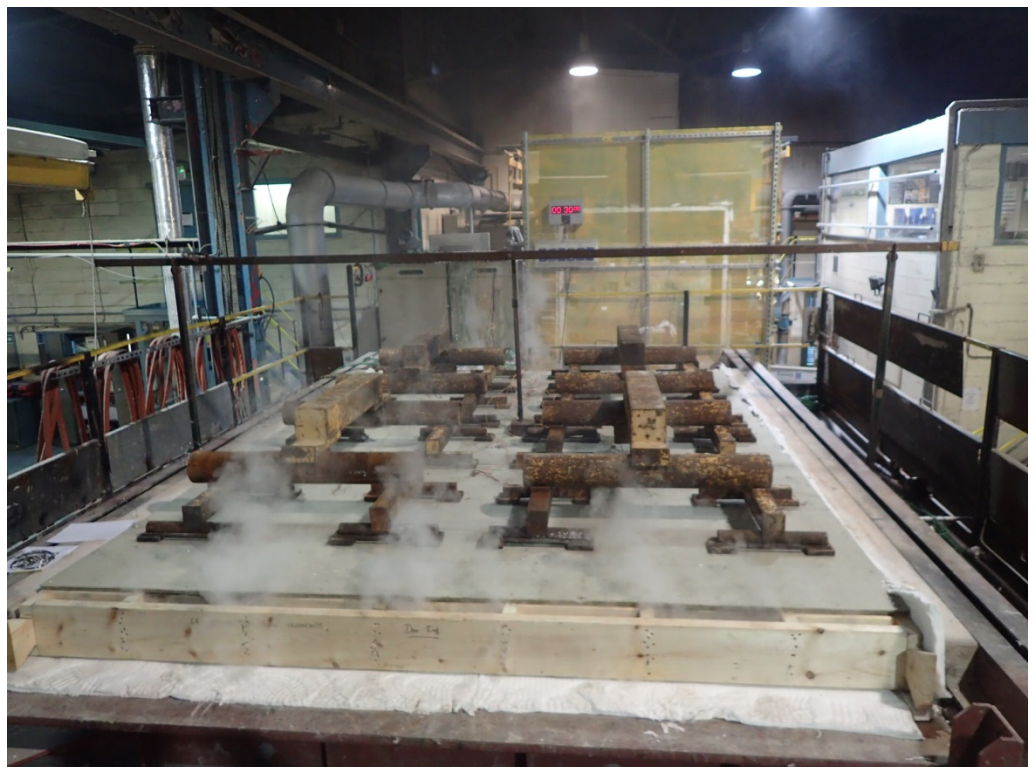
The unexposed face of the assembly after 30 minutes of testing

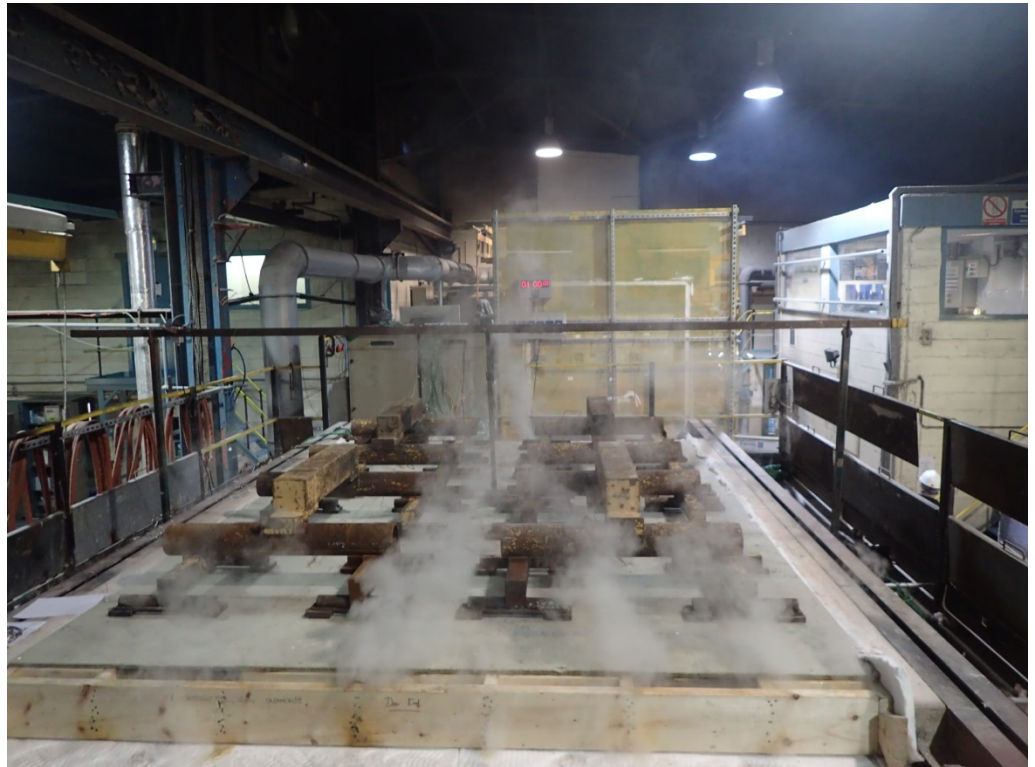
The unexposed face of the assembly after a test duration of approximately 60 minutes

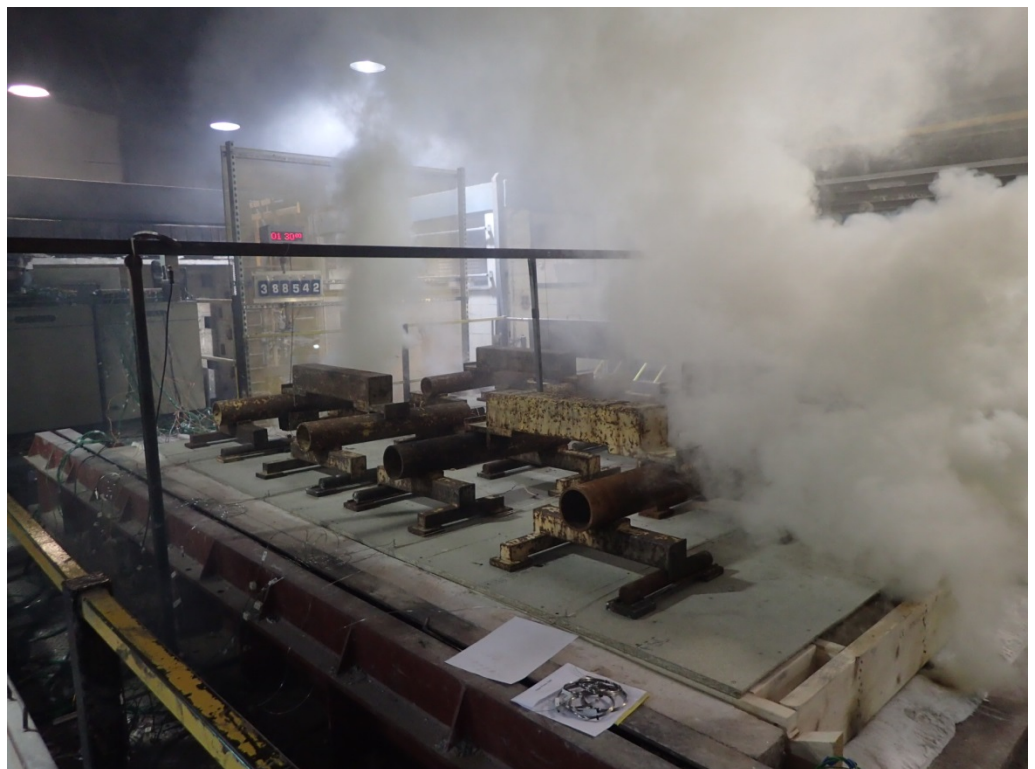
The unexposed face of the assembly after 90 minutes of testing

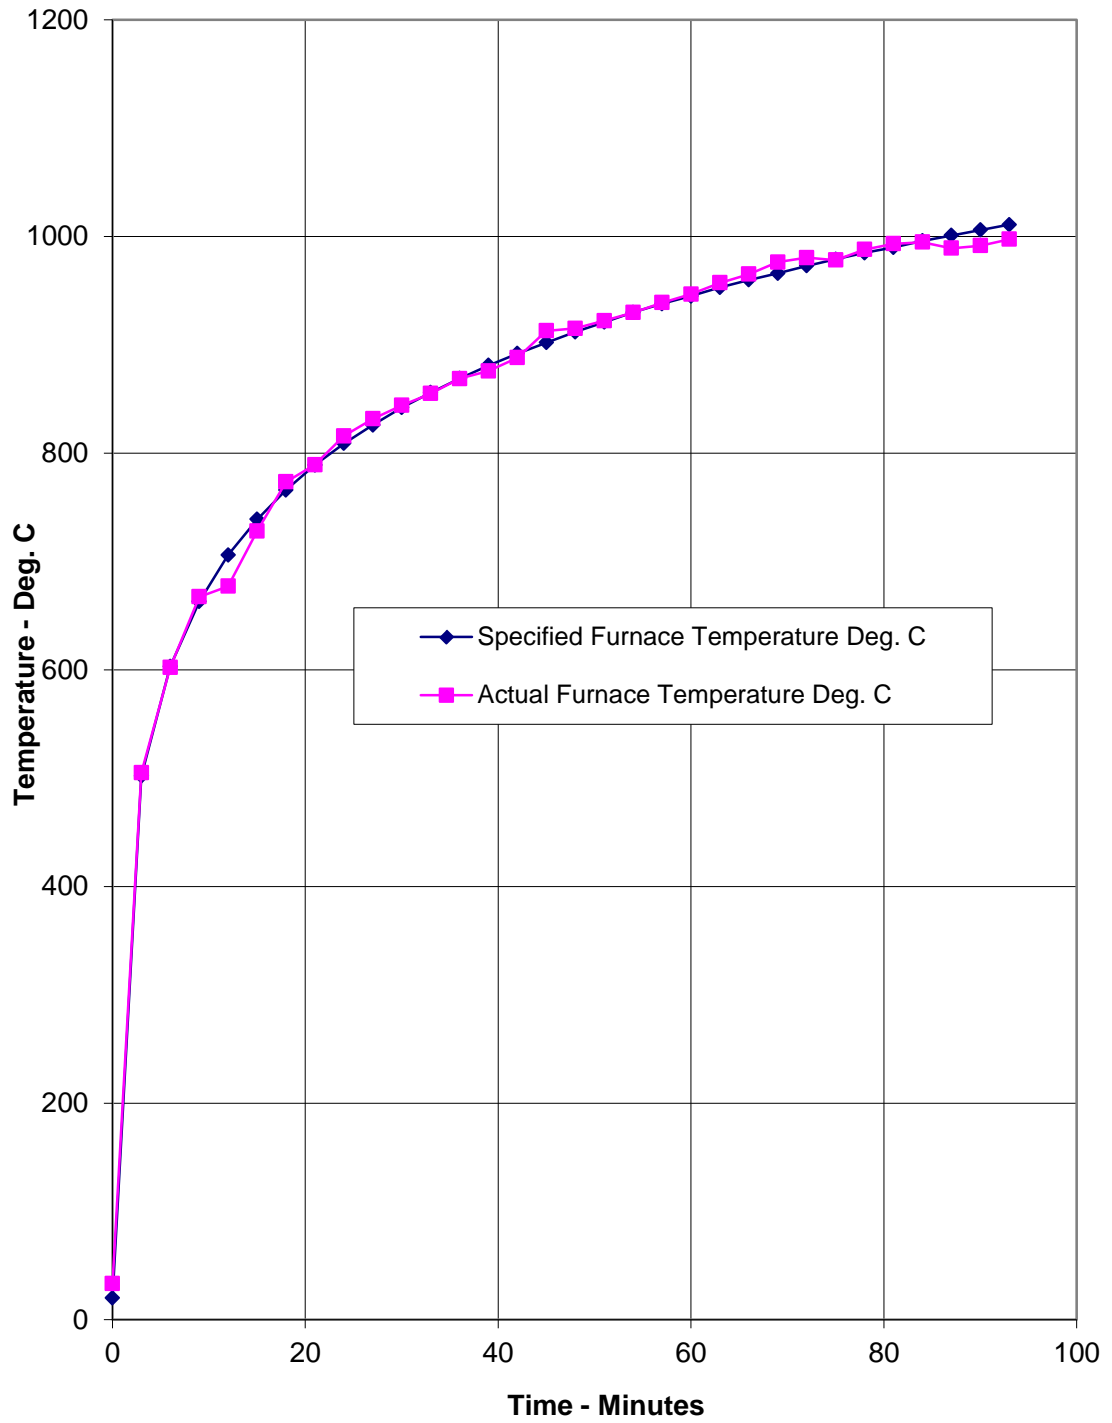
Graph showing specified and actual furnace temperatures

Time Mins	Specified Furnace Temperature Deg. C	Actual Furnace Temperature Deg. C
0	20	33
3	502	505
6	603	602
9	663	667
12	706	677
15	739	728
18	766	774
21	789	789
24	809	816
27	826	832
30	842	844
33	856	855
36	869	869
39	881	876
42	892	888
45	902	913
48	912	915
51	921	922
54	930	930
57	938	939
60	945	947
63	953	957
66	960	965
69	966	976
72	973	981
75	979	978
78	985	988
81	990	993
84	996	995
87	1001	989
90	1006	992
93	1011	997

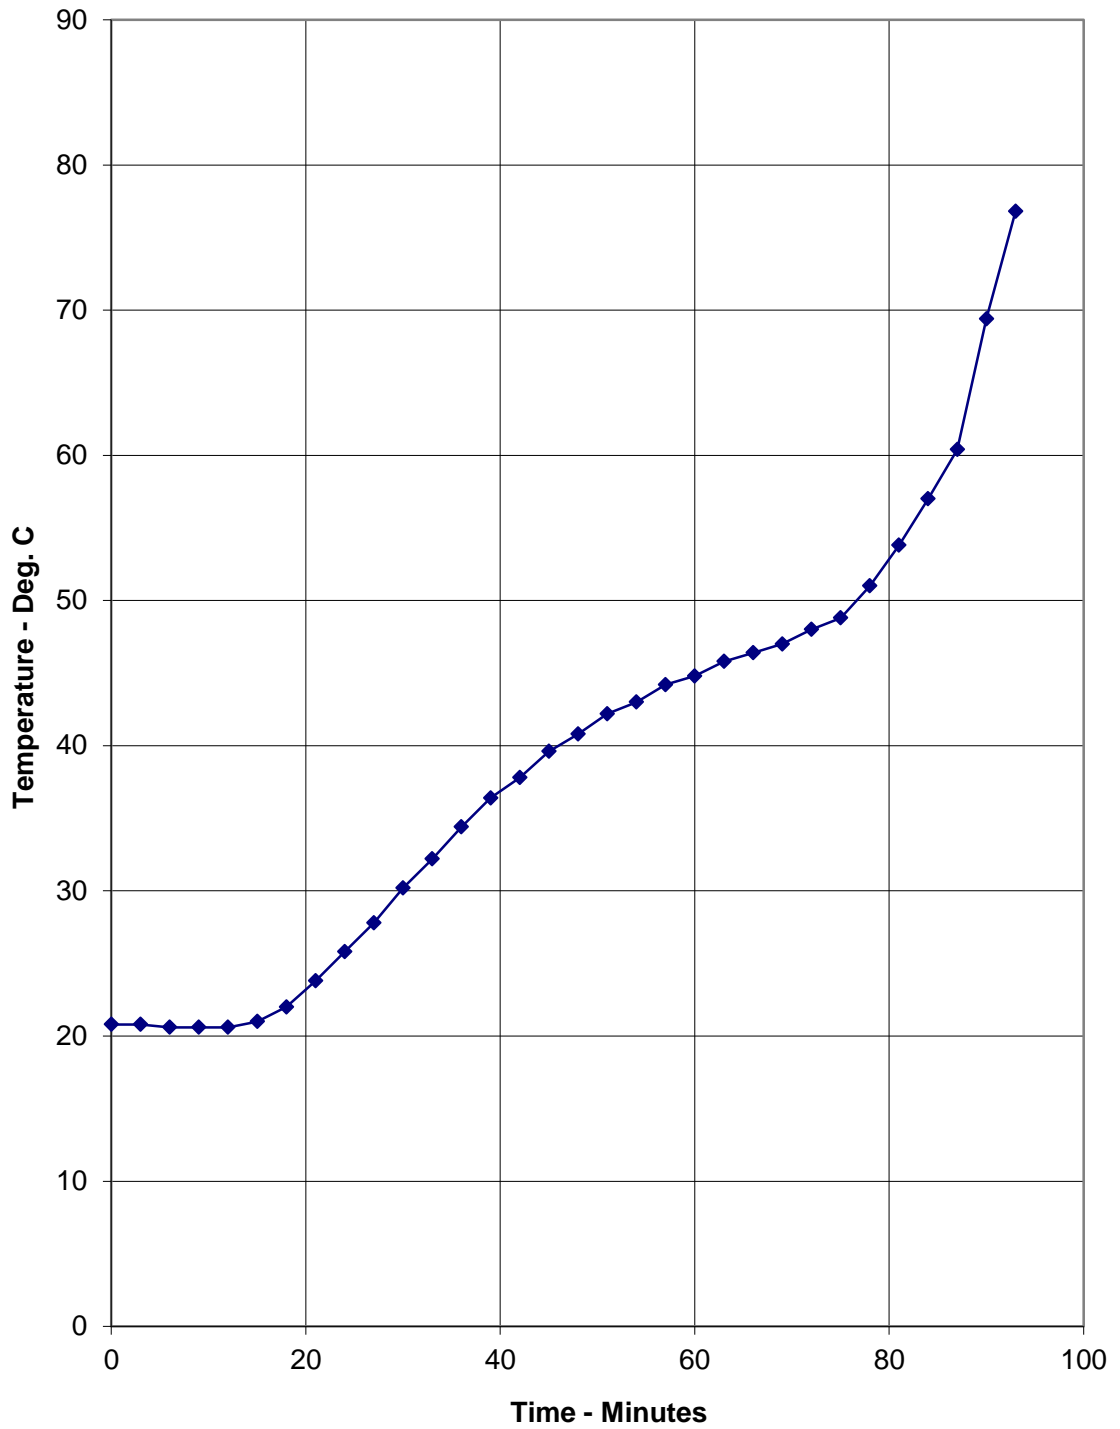
Graph showing mean unexposed surface temperature of the floor assembly

Time Mins	T/C Number 212 Deg. C	T/C Number 213 Deg. C	T/C Number 214 Deg. C	T/C Number 215 Deg. C	T/C Number 216 Deg. C	Mean Temp Deg. C
0	22	22	22	19	19	21
3	22	22	22	19	19	21
6	22	22	21	19	19	21
9	22	22	21	19	19	21
12	22	22	21	19	19	21
15	22	22	22	20	19	21
18	24	23	22	21	20	22
21	26	25	23	23	22	24
24	28	27	24	26	24	26
27	31	29	25	28	26	28
30	34	31	27	31	28	30
33	37	33	28	33	30	32
36	40	35	30	35	32	34
39	43	37	31	37	34	36
42	45	38	32	38	36	38
45	47	40	34	40	37	40
48	48	42	35	41	38	41
51	50	43	36	42	40	42
54	51	44	37	43	40	43
57	52	46	38	44	41	44
60	52	47	38	45	42	45
63	53	48	39	46	43	46
66	54	48	40	47	43	46
69	54	49	41	47	44	47
72	55	50	41	48	46	48
75	55	50	41	49	49	49
78	56	51	42	50	56	51
81	58	53	43	51	64	54
84	60	55	45	54	71	57
87	62	58	48	57	77	60
90	67	61	64	73	82	69
93	74	71	75	82	82	77

It is required that the mean temperature rise of the unexposed surface shall not be greater than 140°C and that the maximum temperature rise shall not be greater than 180°C. Insulation failure also occurs simultaneously with integrity failure. The test construction satisfied this requirement for the total test duration of 93 minutes.

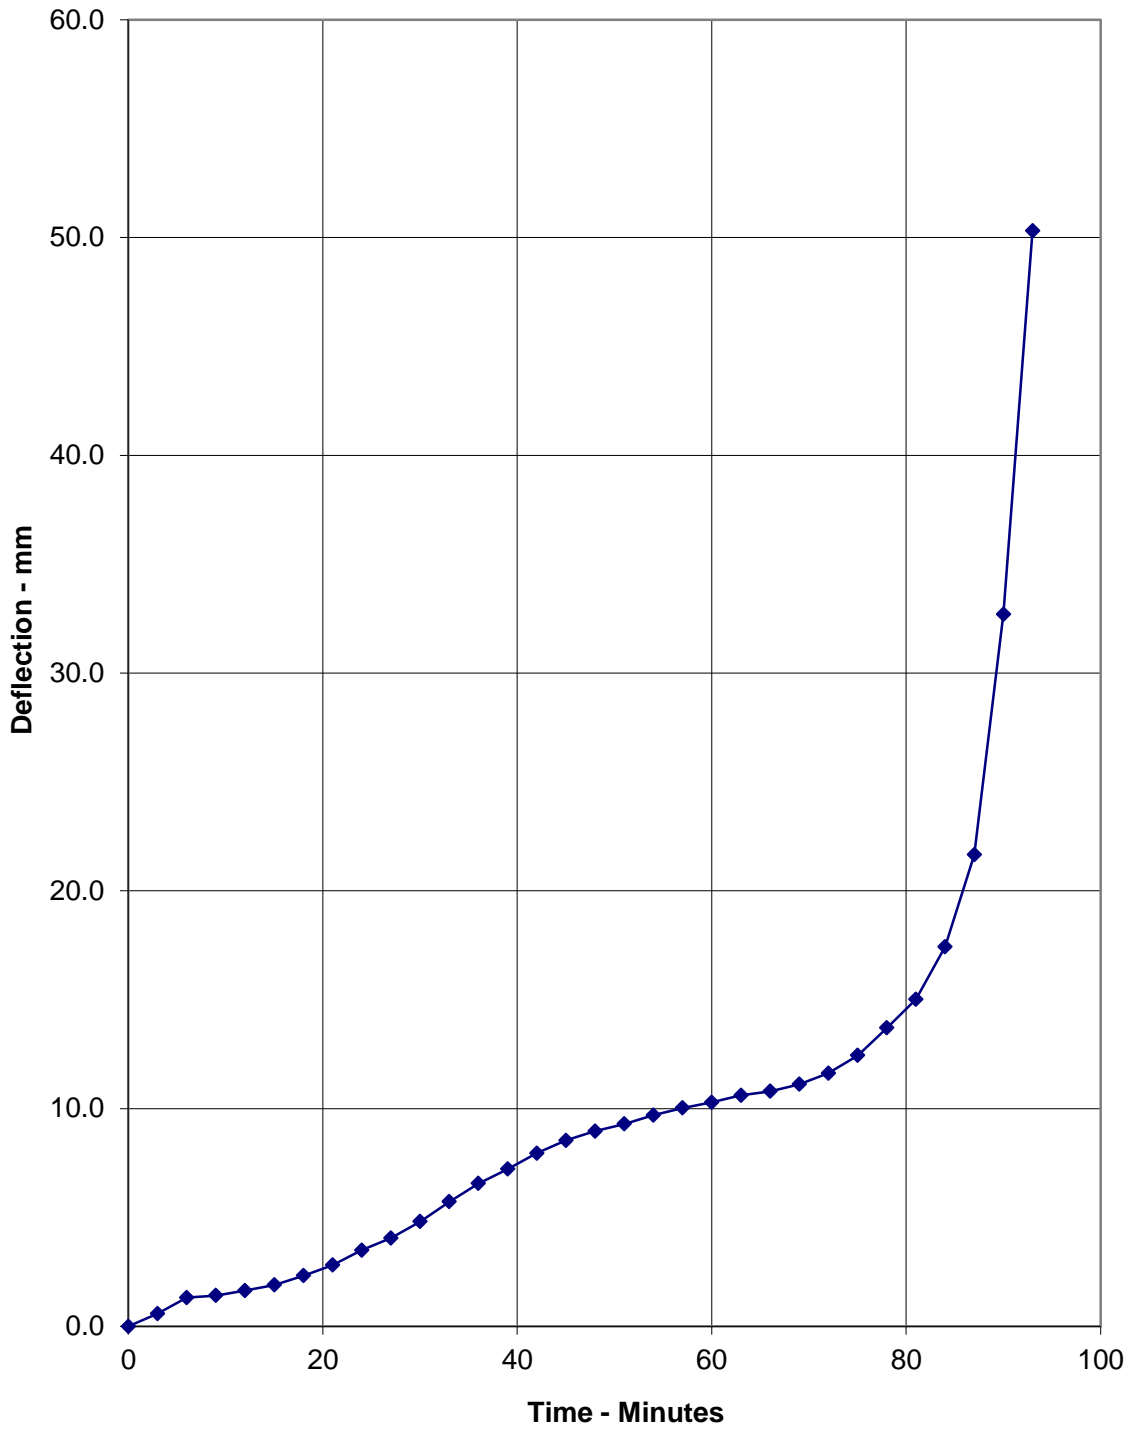
Graph showing the central vertical deflection of the floor assembly during the test

Time Mins	Central Vertical Deflection mm	Rate of Deflection mm/min
0	0.0	0.0
3	0.6	0.3
6	1.3	0.0
9	1.4	0.0
12	1.6	0.0
15	1.9	0.0
18	2.3	0.0
21	2.8	0.2
24	3.5	0.3
27	4.1	0.2
30	4.8	0.3
33	5.7	0.3
36	6.6	0.3
39	7.2	0.3
42	8.0	0.2
45	8.5	0.1
48	9.0	0.1
51	9.3	0.1
54	9.7	0.2
57	10.0	0.2
60	10.3	-0.1
63	10.6	0.2
66	10.8	0.0
69	11.1	0.2
72	11.6	0.2
75	12.4	0.3
78	13.7	0.5
81	15.0	0.5
84	17.4	0.7
87	21.7	2.2
90	32.7	4.4
93	50.3	6.7

The maximum allowable deflection and the maximum rate of deflection for the specimen, as specified by the Standard, are calculated as 200 mm and 9.11 mm per minute respectively. The allowable rate of deflection is not applicable until the deflection exceeds $\frac{1}{30}$ of the span (i.e. 140 mm). The test construction satisfied this requirement for the total test duration of 93 minutes.
