The Fire Resistance Performance of a Specimen of a Loadbearing Timber Floor Assembly Protected by a Plasterboard Ceiling Designed to Provide 60 minutes Fire Resistance, Incorporating Twenty Downlight Light Fittings, Tested in Accordance with BS 476: Part 21: 1987, Clause 7

371969B

**Integral LED**

19<sup>th</sup> May 2017

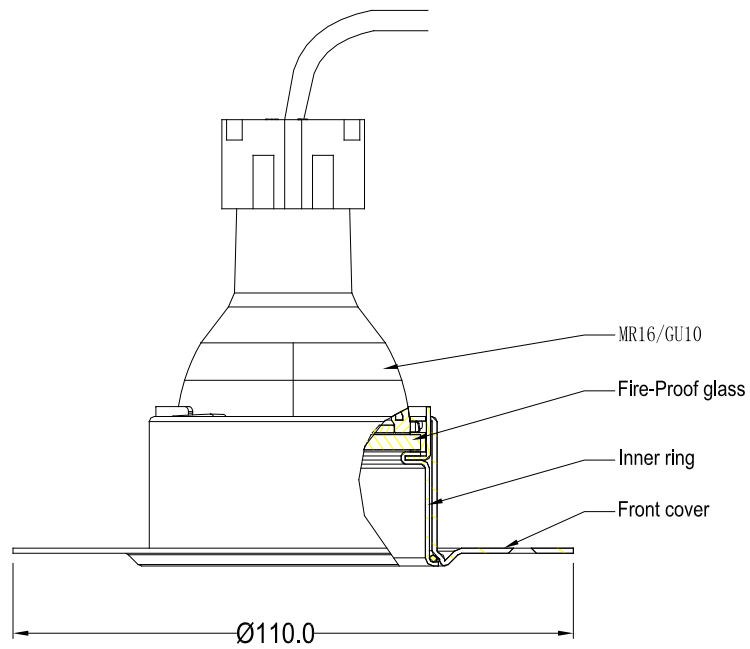
Figure 3 – Details of Downlighter Specimen A

Fixed  
ILD LFR60FXXX  
Cut out:  $\text{Ø}60$

i. front cover	: Steel
ii. inner ring	: Steel
iii. spring	: Stainless steel
iv. diffuser	: Pyrex glass
Overall dimensions and construction	: See Figures 3 to 7.
Cut out size	: Varies see relevant figure.
Driver	: None
Lamp	: GU10/MR16

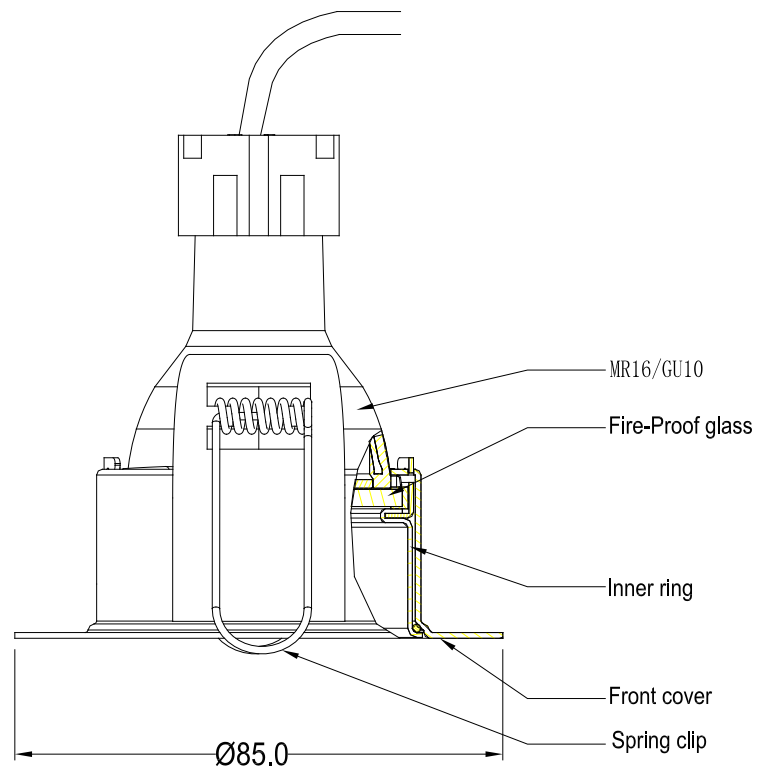
Figure 4 – Details of Downlighter Specimen B

Fixed  
ILD LFR70EXXX  
Cut out:  $\text{Ø}70$

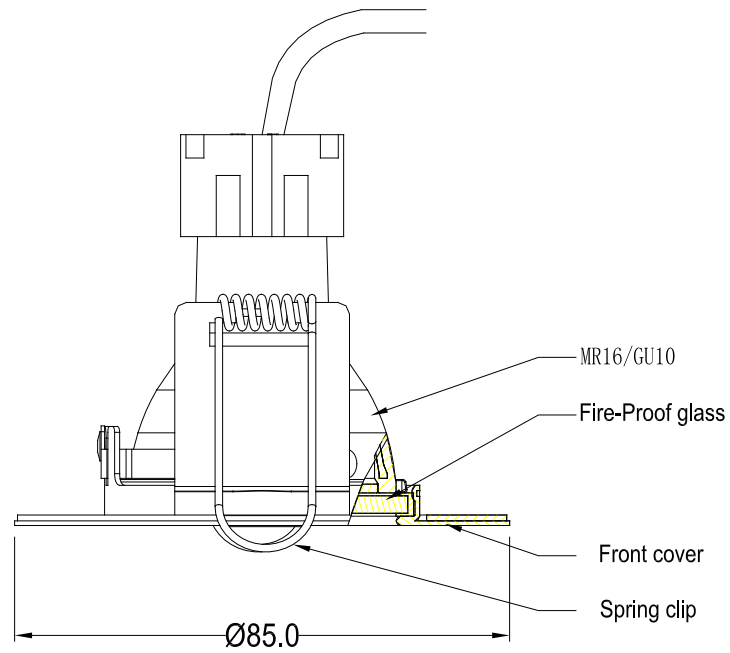
Figure 6 – Details of Downlighter Specimen D

Fixed  
ILD LFR70DXXX  
Cut out:  $\text{Ø}70$

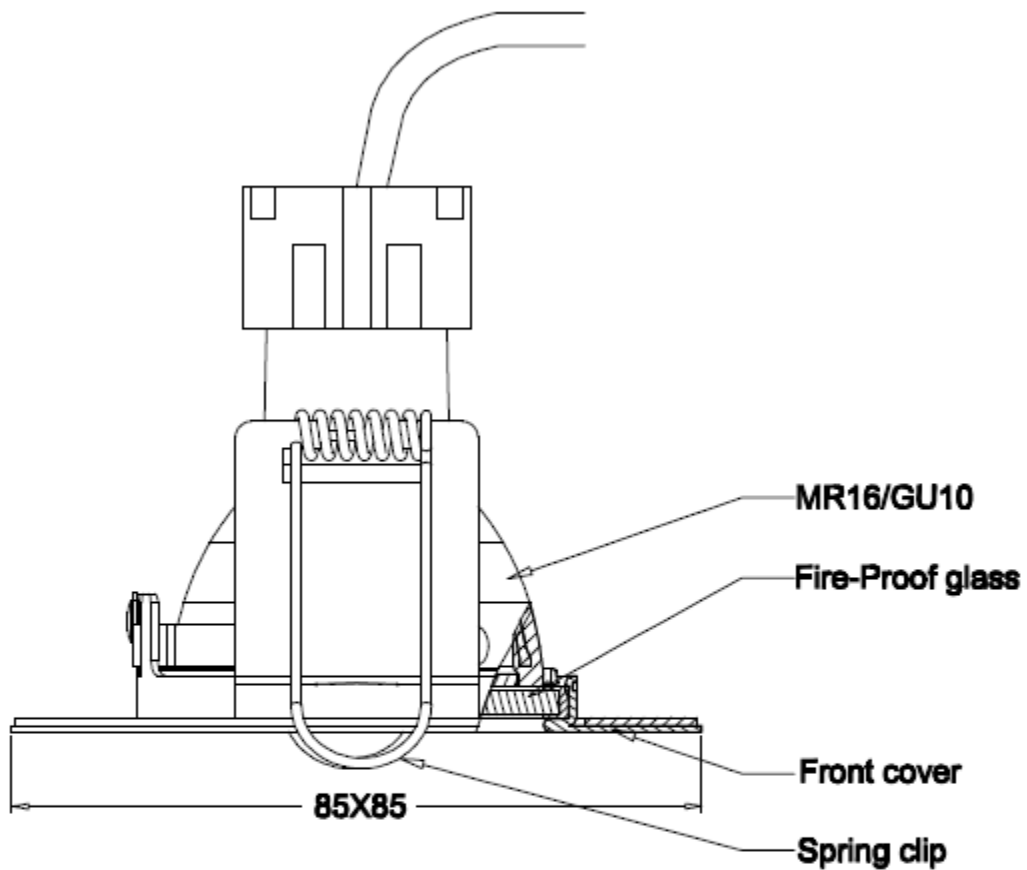
Figure 8 – Details of Downlighter Specimen F

**Fixed model  
ILDLFR70DXXX  
Slim fire square bezel  
Cut out:Ø70mm**

<b><u>Item</u></b>	<b><u>Description</u></b>
<b>3. Specimen F, G, H, I</b>	
Manufacturer	: Integral LED
Type	: Square, fixed, LED recessed downlight
Reference	: See Figures 8 to 11.
Materials	
i. front cover	: Steel
ii. spring	: Stainless steel
iii. diffuser	: Pyrex glass
Overall dimensions and construction	: Please see Figures 8 to 11
Cut out size	: Various see relevant figures
Driver	: None
Lamp	: GU10/MR16
<b>4. Specimen J</b>	: Specimen reported separately
<b>5. Specimen K, L</b>	: Specimens reported separately
<b>6. Specimen M, N</b>	: Specimens reported separately
<b>7. Specimens O</b>	: Specimen reported separately
<b>8. Specimens P</b>	: Specimen reported separately
<b>9. Specimen Q</b>	: Specimen reported separately
<b>10. Specimens R, S</b>	: Specimens reported separately
<b>11. Specimen T</b>	: Specimen reported separately
