The Fire Resistance Performance of a Specimen of a Loadbearing Timber Floor Assembly Protected by a Plasterboard Ceiling Designed to Provide 60 minutes Fire Resistance, Incorporating Twenty Downlight Light Fittings, Tested in Accordance with BS 476: Part 21: 1987, Clause 7

371969B

Integral LED

19th May 2017

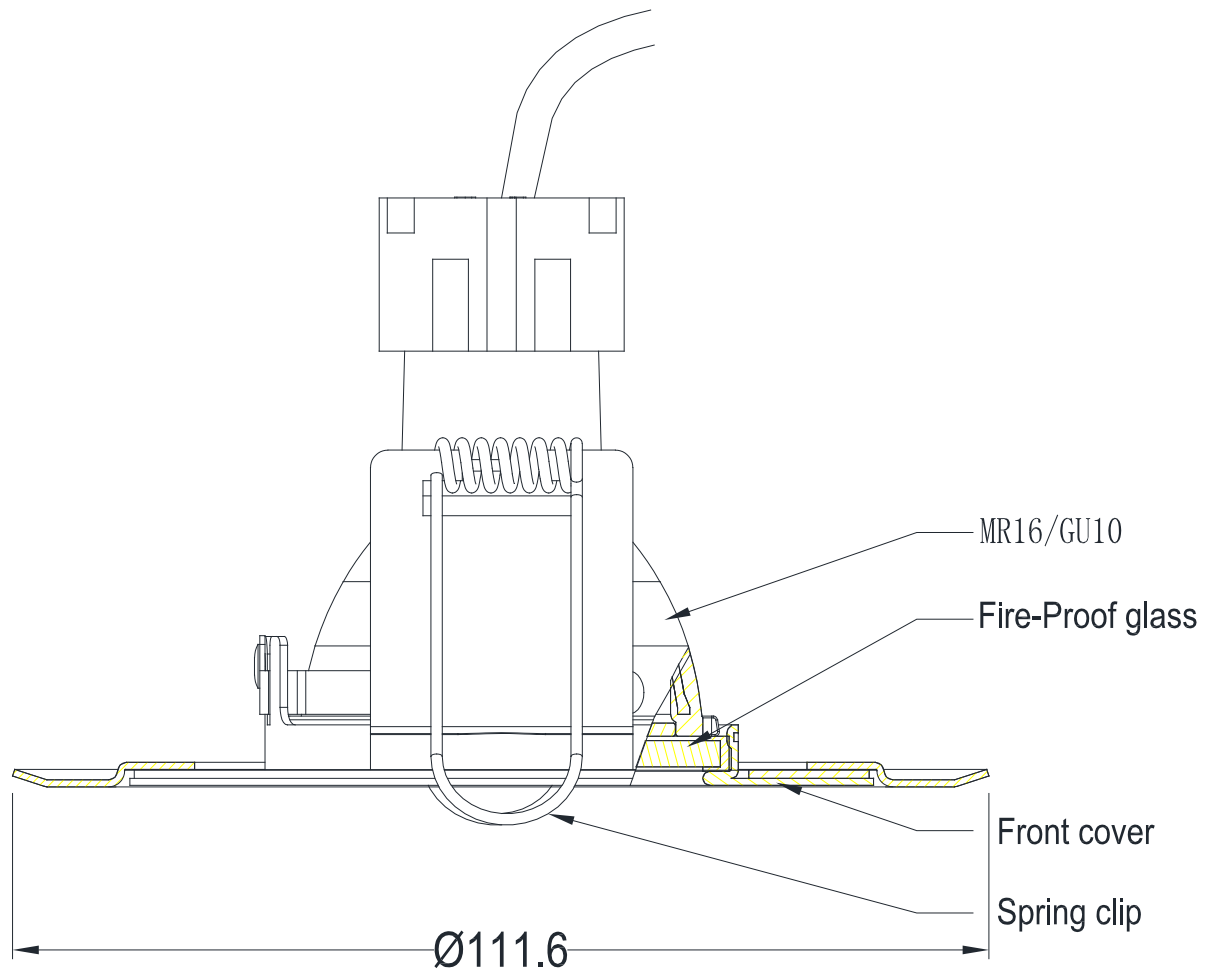
Figure 7 – Details of Downlighter Specimen E

Fixed
ILD LFR70DXXX
accessory of Slim Fire
Cut out: $\text{Ø}100\text{mm}$

2. Specimens A, B, C, D, E	
Manufacturer	: Integral LED
Type	: Round, fixed, Agate LED recessed downlight
Reference	: See Figures 3 to 7.
Materials	
i. front cover	: Steel
ii. inner ring	: Steel
iii. spring	: Stainless steel
iv. diffuser	: Pyrex glass
Overall dimensions and construction	: See Figures 3 to 7.
Cut out size	: Varies see relevant figure.
Driver	: None
Lamp	: GU10/MR16

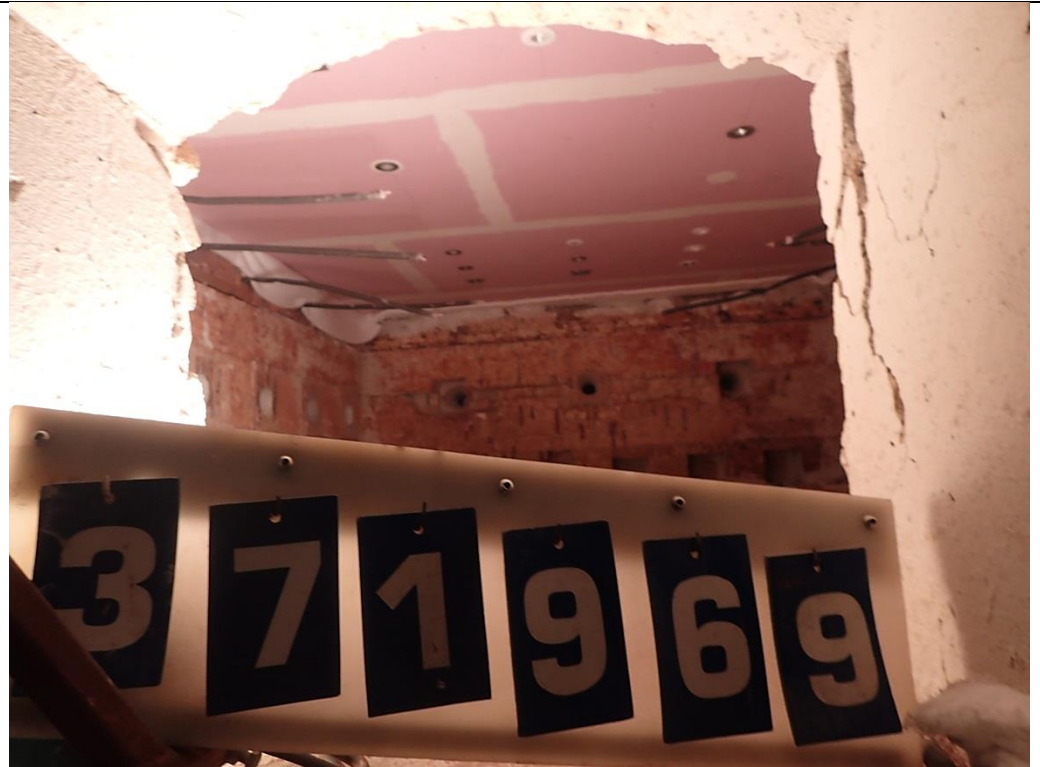
The exposed face of the assembly prior to testing

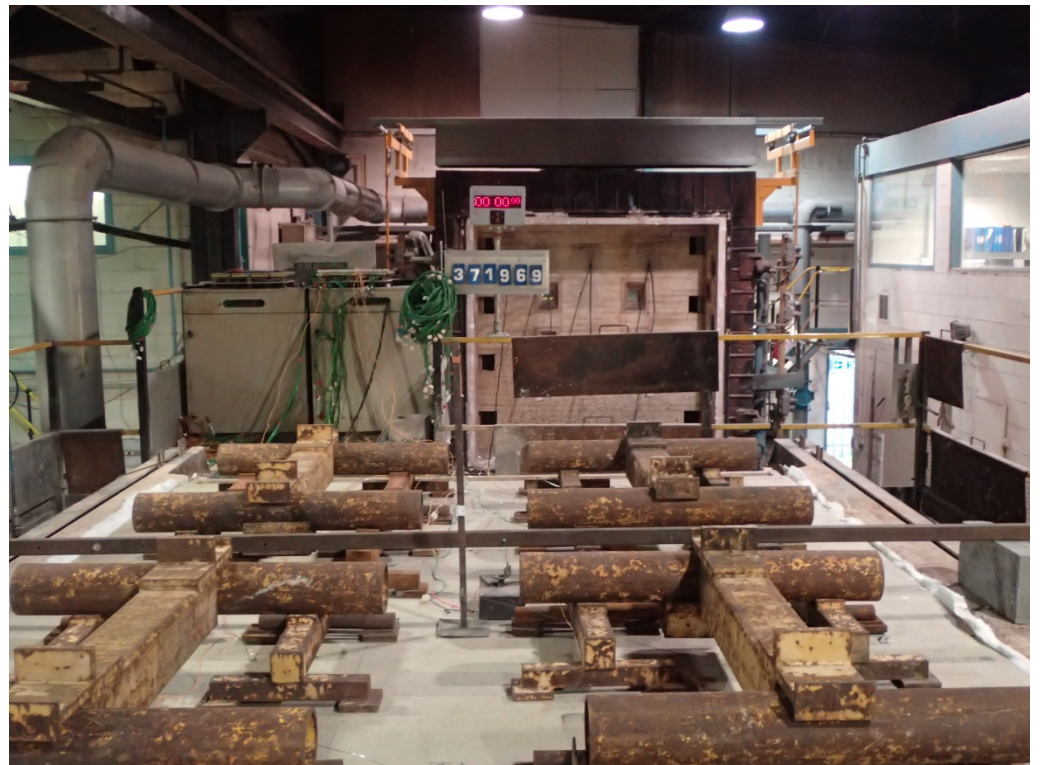
The unexposed face of the assembly after 10 minutes of testing

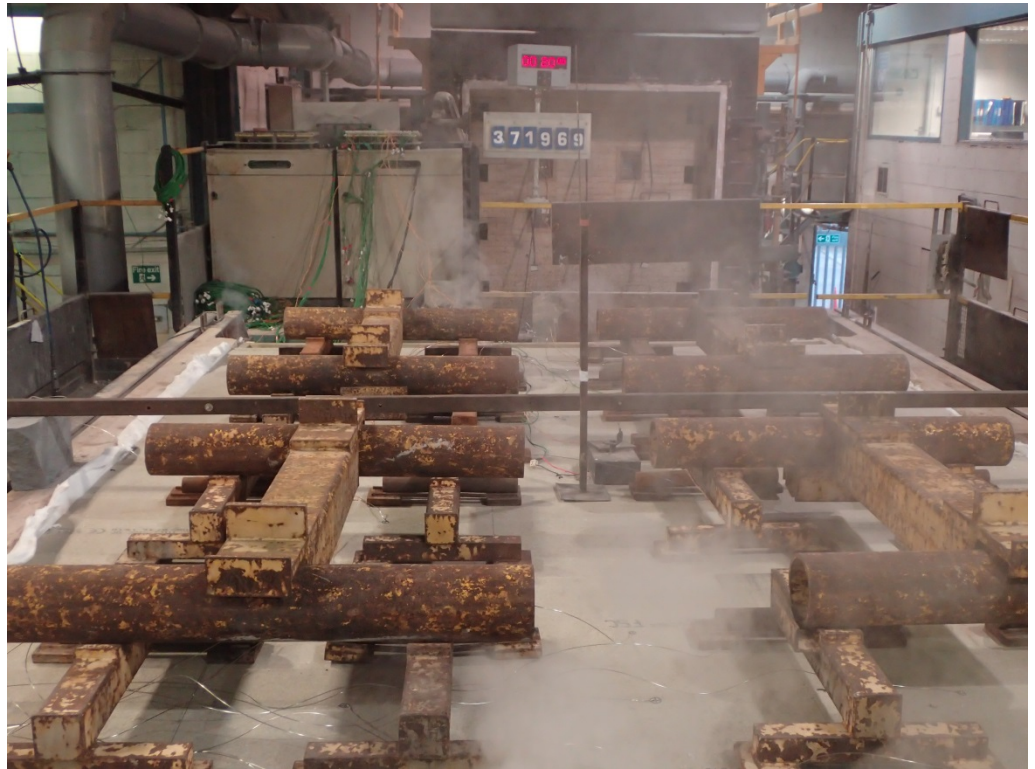
The unexposed face of the assembly after 20 minutes of testing

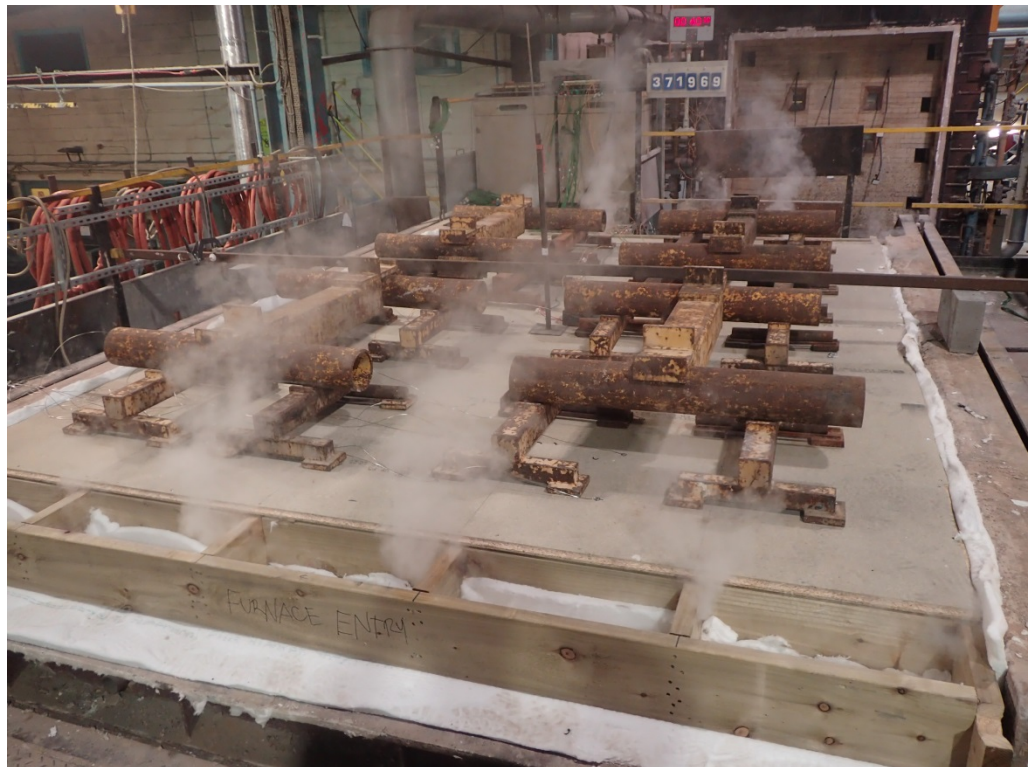
The unexposed face of the assembly after 40 minutes of testing

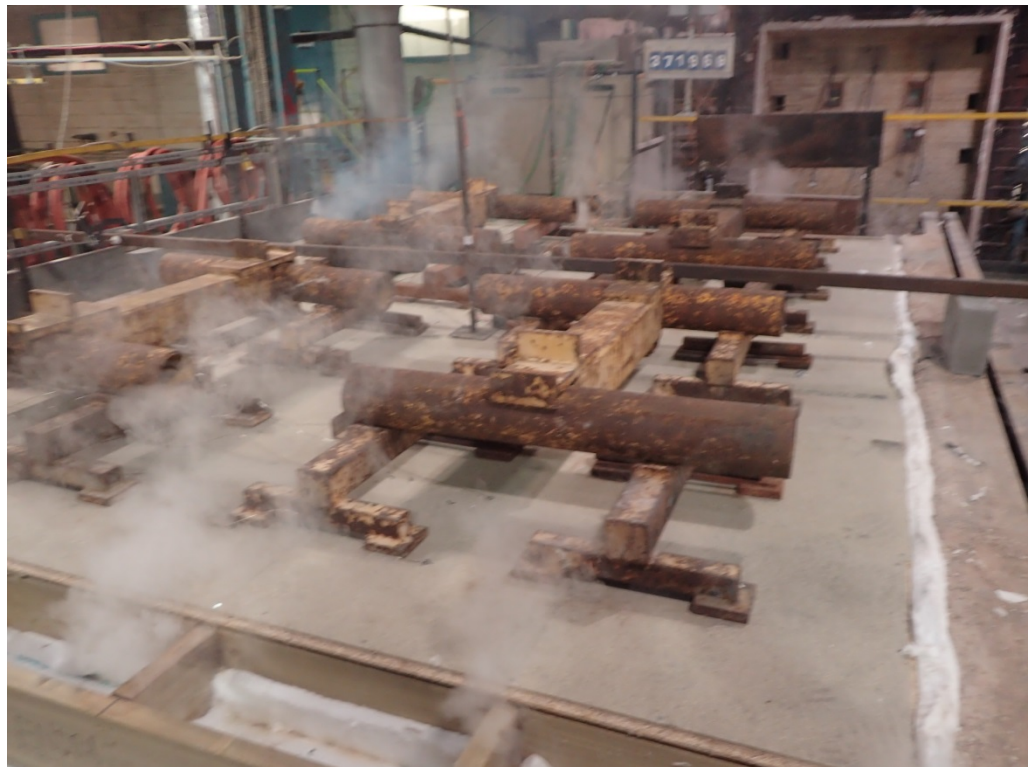
The unexposed face of the assembly after 60 minutes of testing

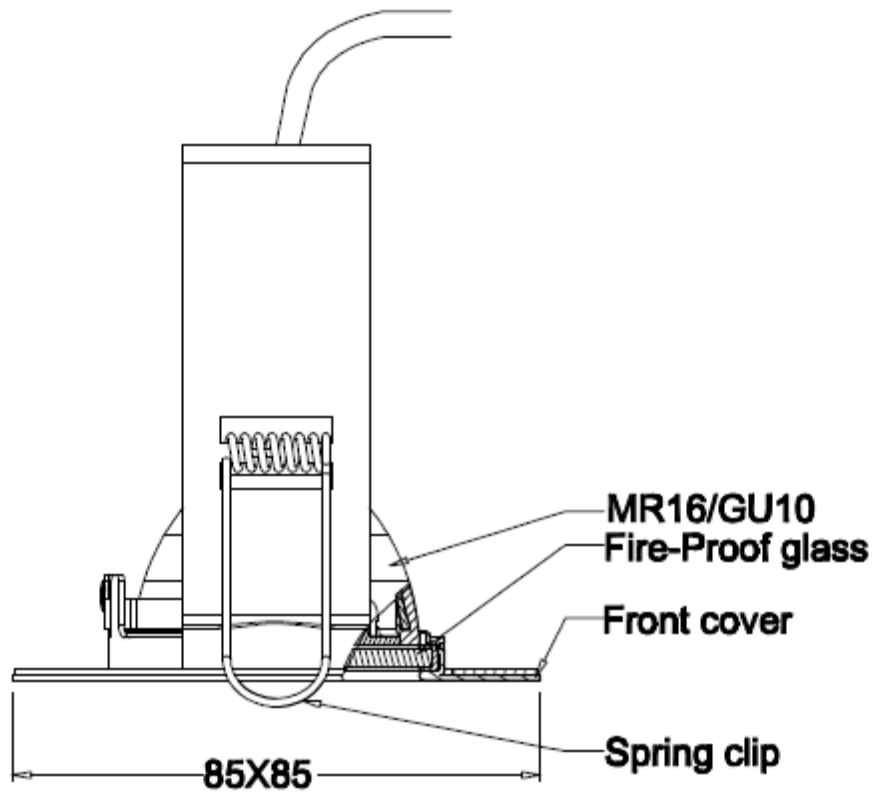
Figure 9 – Details of Downlighters Specimen G

Fixed model
ILD LFR70DXXX
Slim fire square bezel with bracket
Cut out: Ø70mm

<u>Item</u>	<u>Description</u>
3. Specimen F, G, H, I	
Manufacturer	: Integral LED
Type	: Square, fixed, LED recessed downlight
Reference	: See Figs 8 to 11.
Materials	
i. front cover	: Steel
ii. spring	: Stainless steel
iii. diffuser	: Pyrex glass
Overall dimensions and construction	: Please see Figs. 8 to 11
Cut out size	: Various see relevant figures
Driver	: None
Lamp	: GU10/MR16
4. Specimen J	: Specimen reported separately
5. Specimen K, L	: Specimens reported separately
6. Specimen M, N	: Specimens reported separately
7. Specimens O	: Specimen reported separately
8. Specimens P	: Specimen reported separately
9. Specimen Q	: Specimen reported separately
10. Specimens R, S	: Specimens reported separately
11. Specimen T	: Specimen reported separately

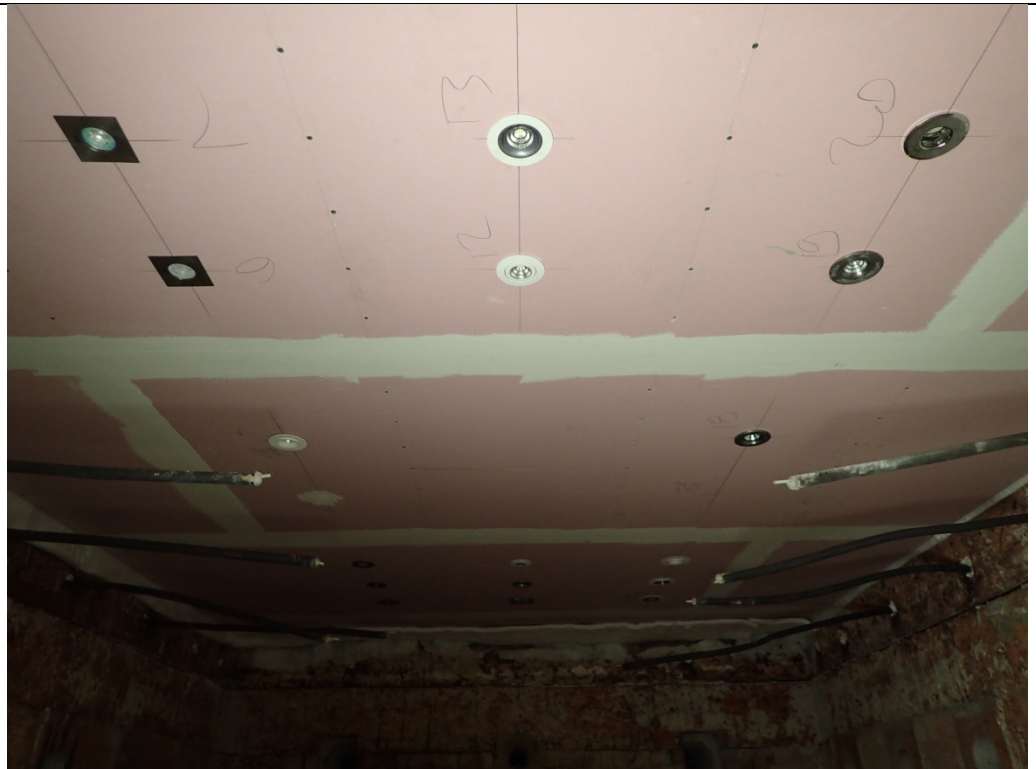
The exposed face of the assembly prior to testing

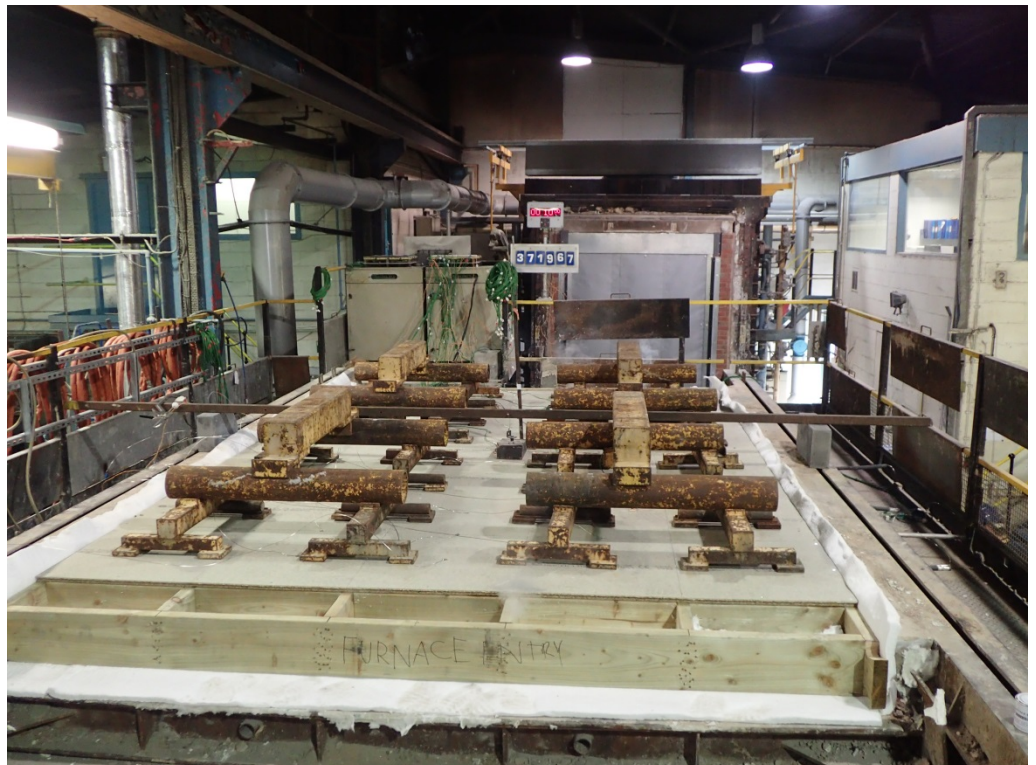
The unexposed face of the assembly after 10 minutes of testing

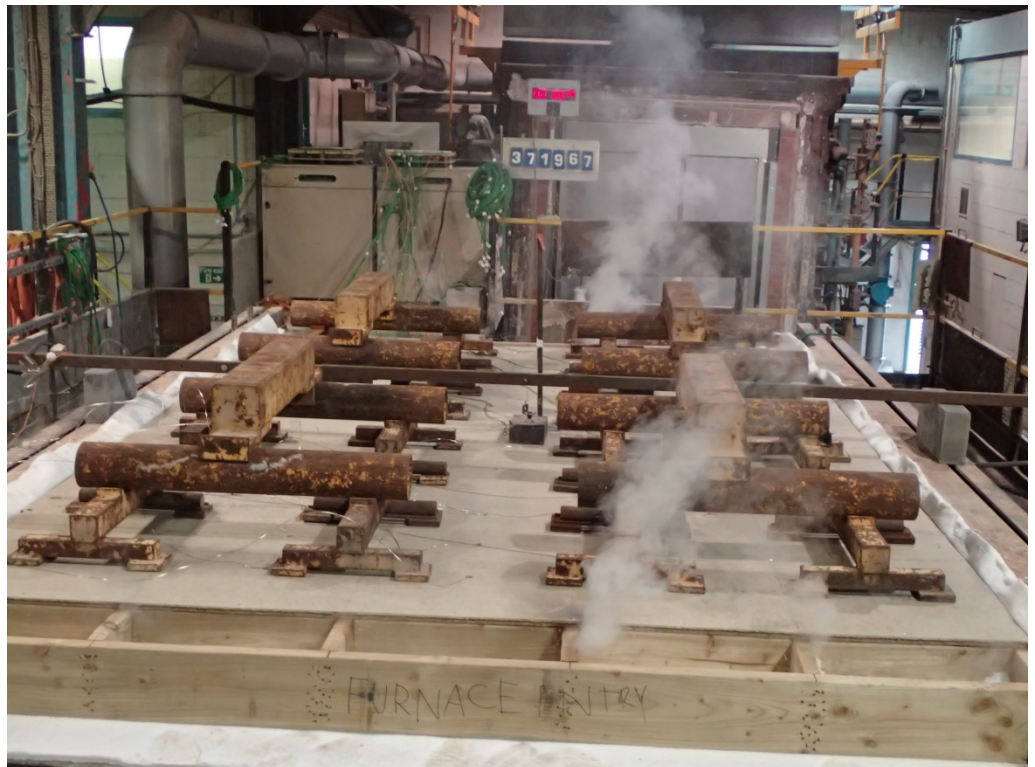
The unexposed face of the assembly after 36 minutes of testing

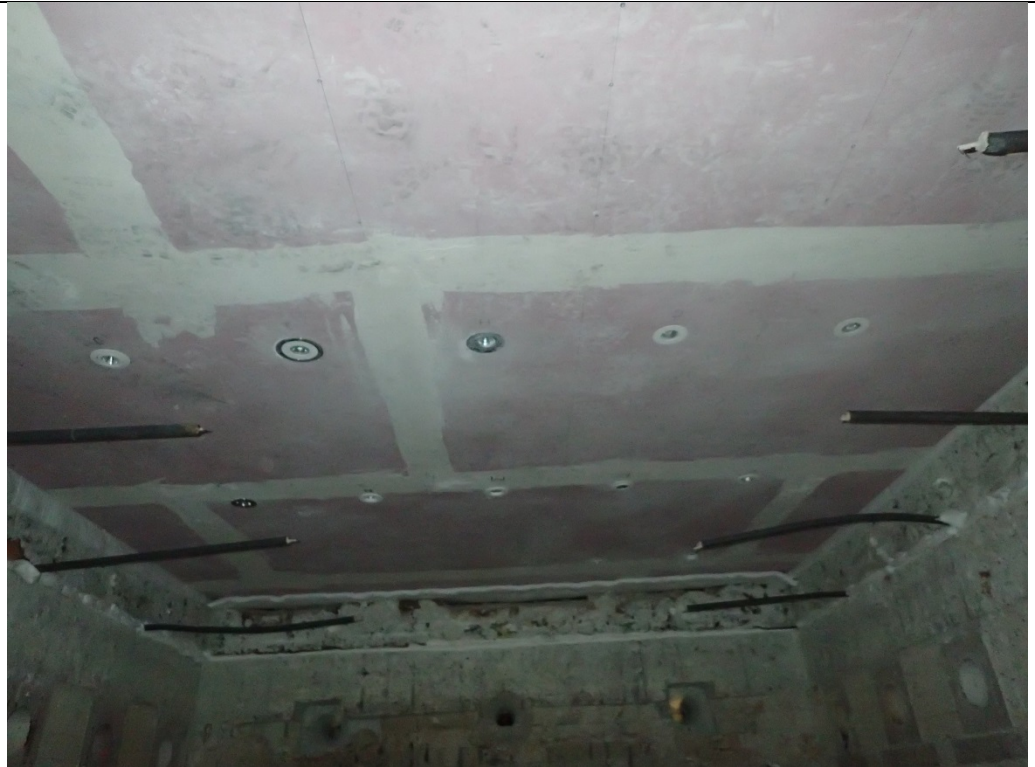
The exposed face of the assembly prior to testing

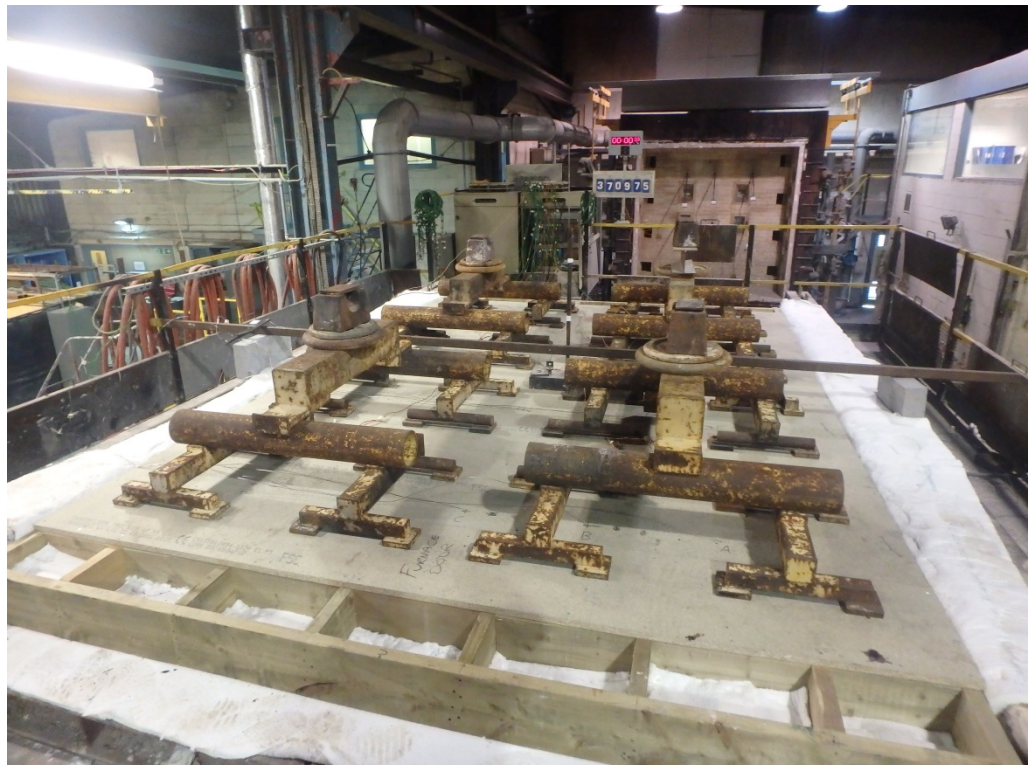
The unexposed face of the assembly prior to the start of the test

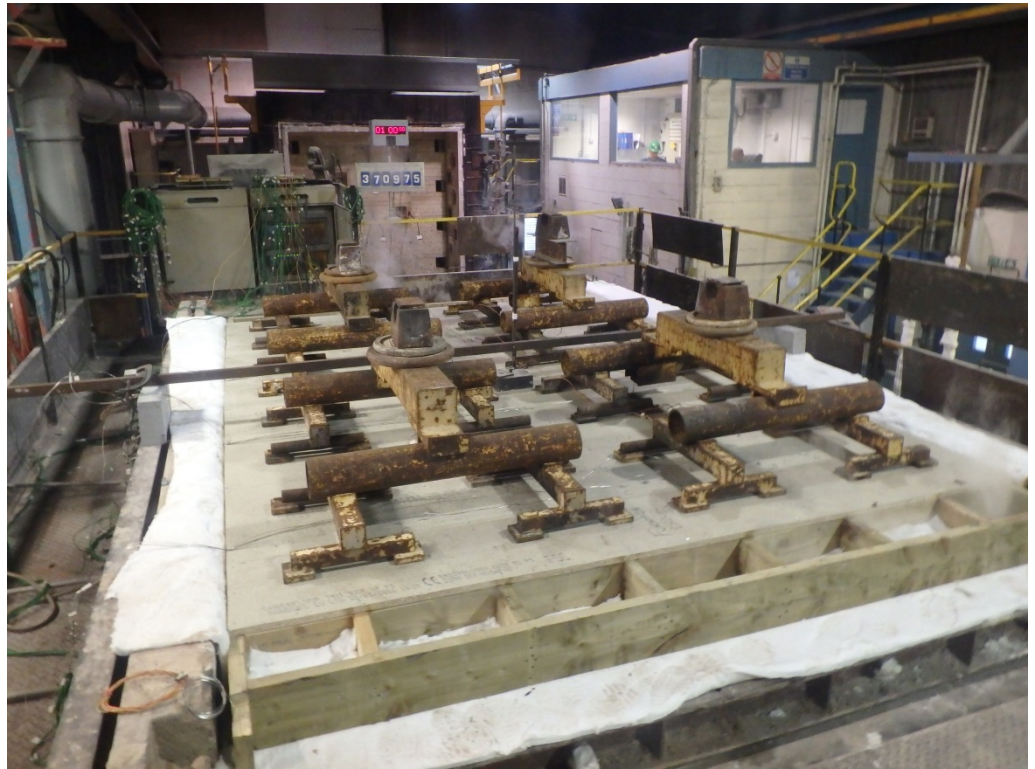
The unexposed face of the assembly after 60 minutes of testing

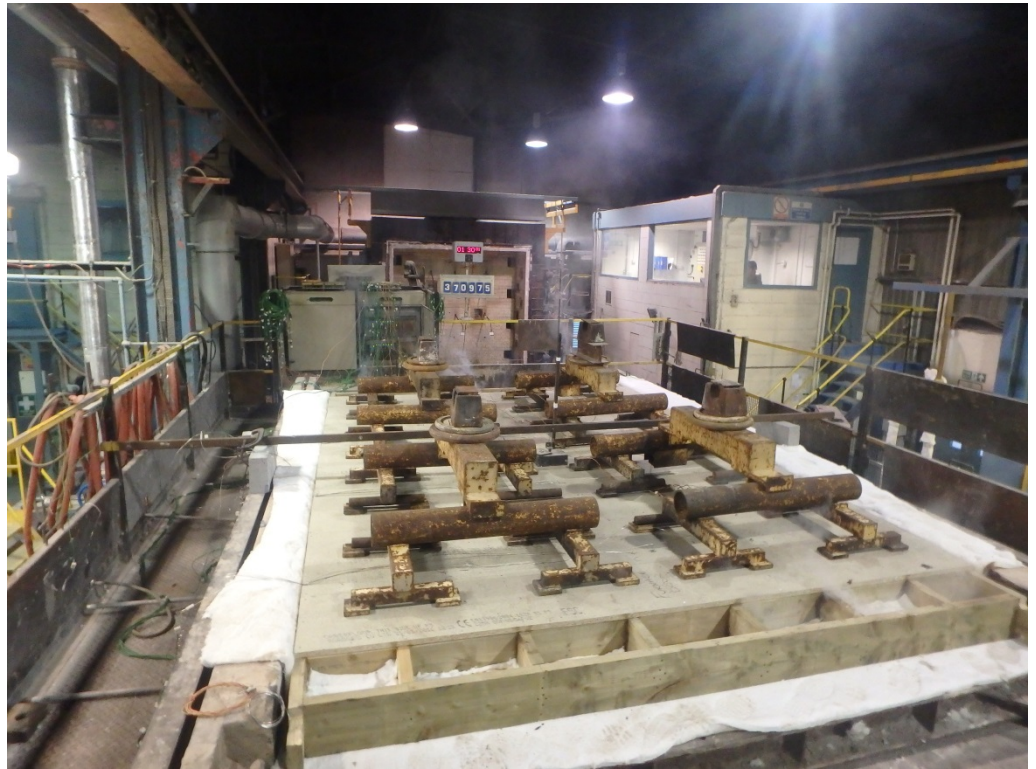
The unexposed
face of the
assembly after 90
minutes of testing
